**STATIC LOAD TESTS ON RESEARCH AND DEVELOPMENT
ATLAS VEHICLE LAUNCHER**

by Holmes Neal
Lewis Research Center
Cleveland, Ohio

NATIONAL AERONAUTICS AND SPACE ADMINISTRATION

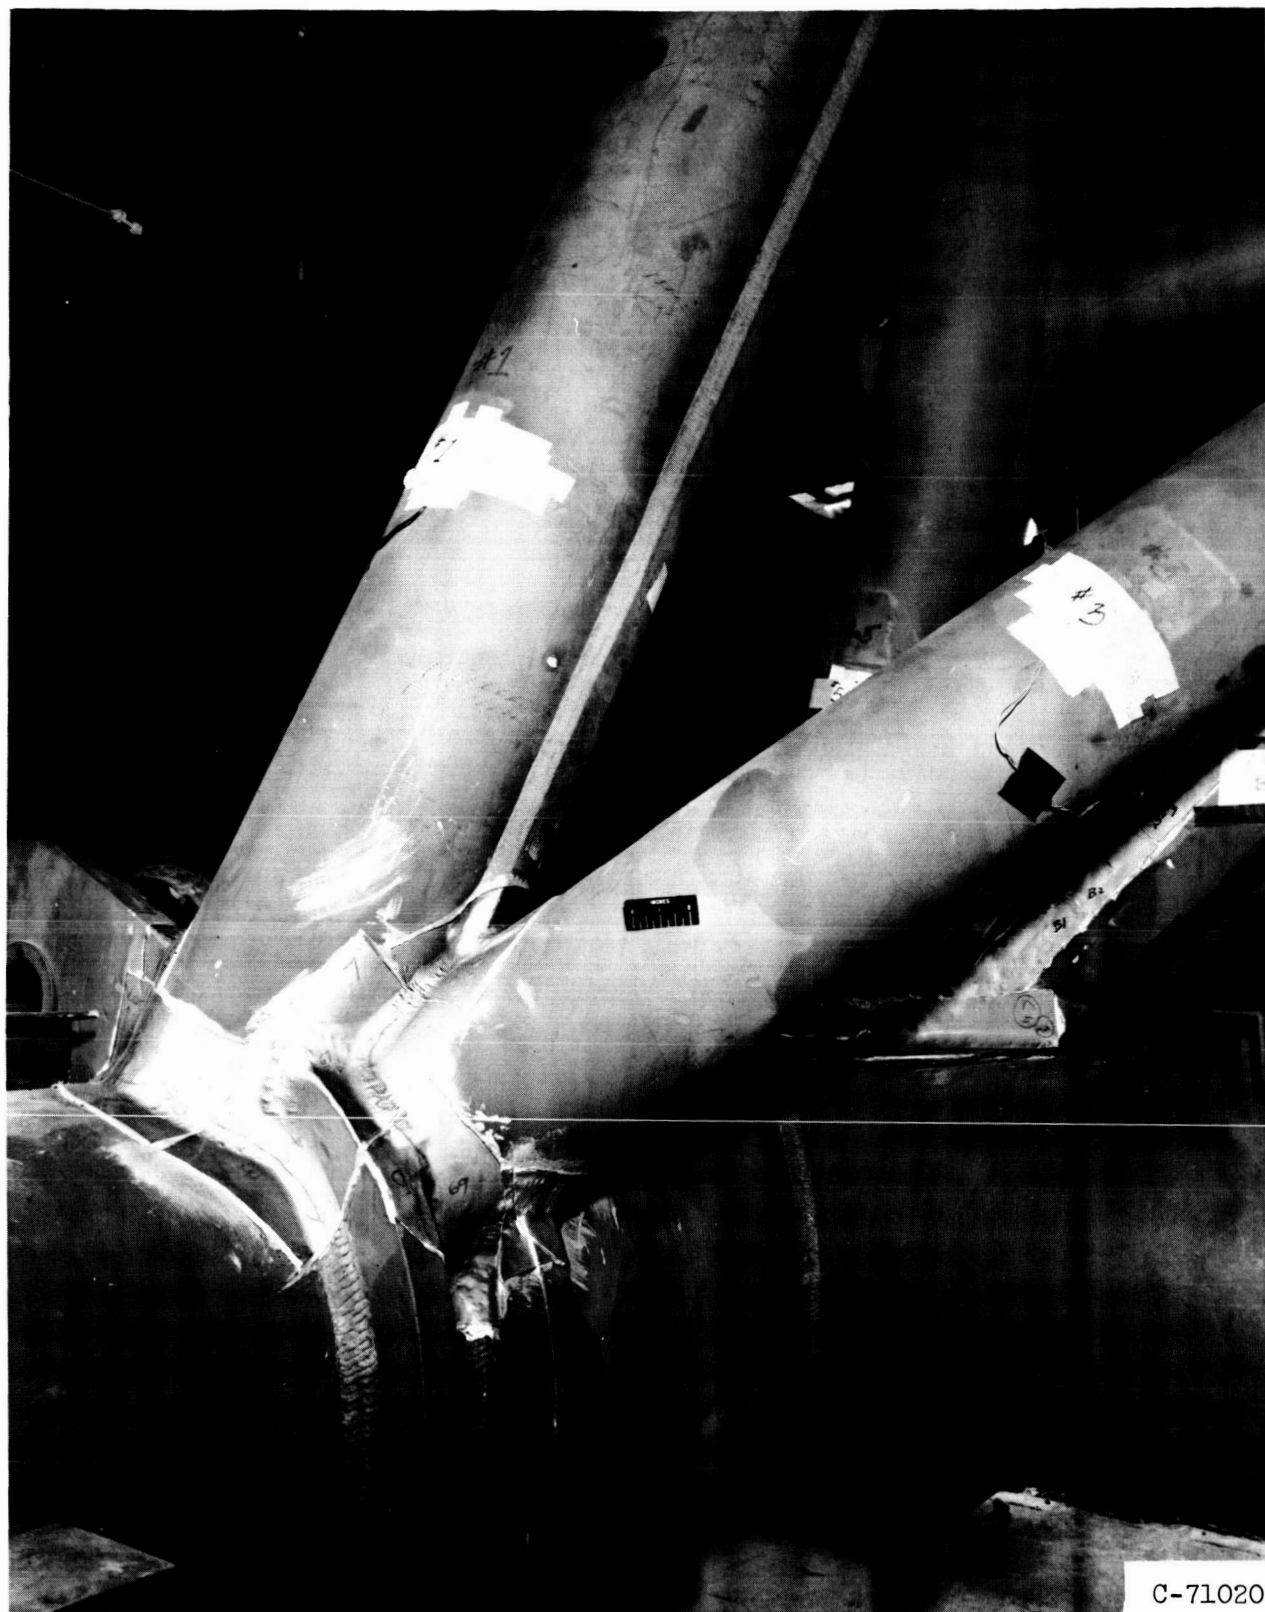
C-71020

Figure 5. - Inside view of diagonal bracing members of horizontal frame joint in quadrant I showing strain gages 1 and 3.

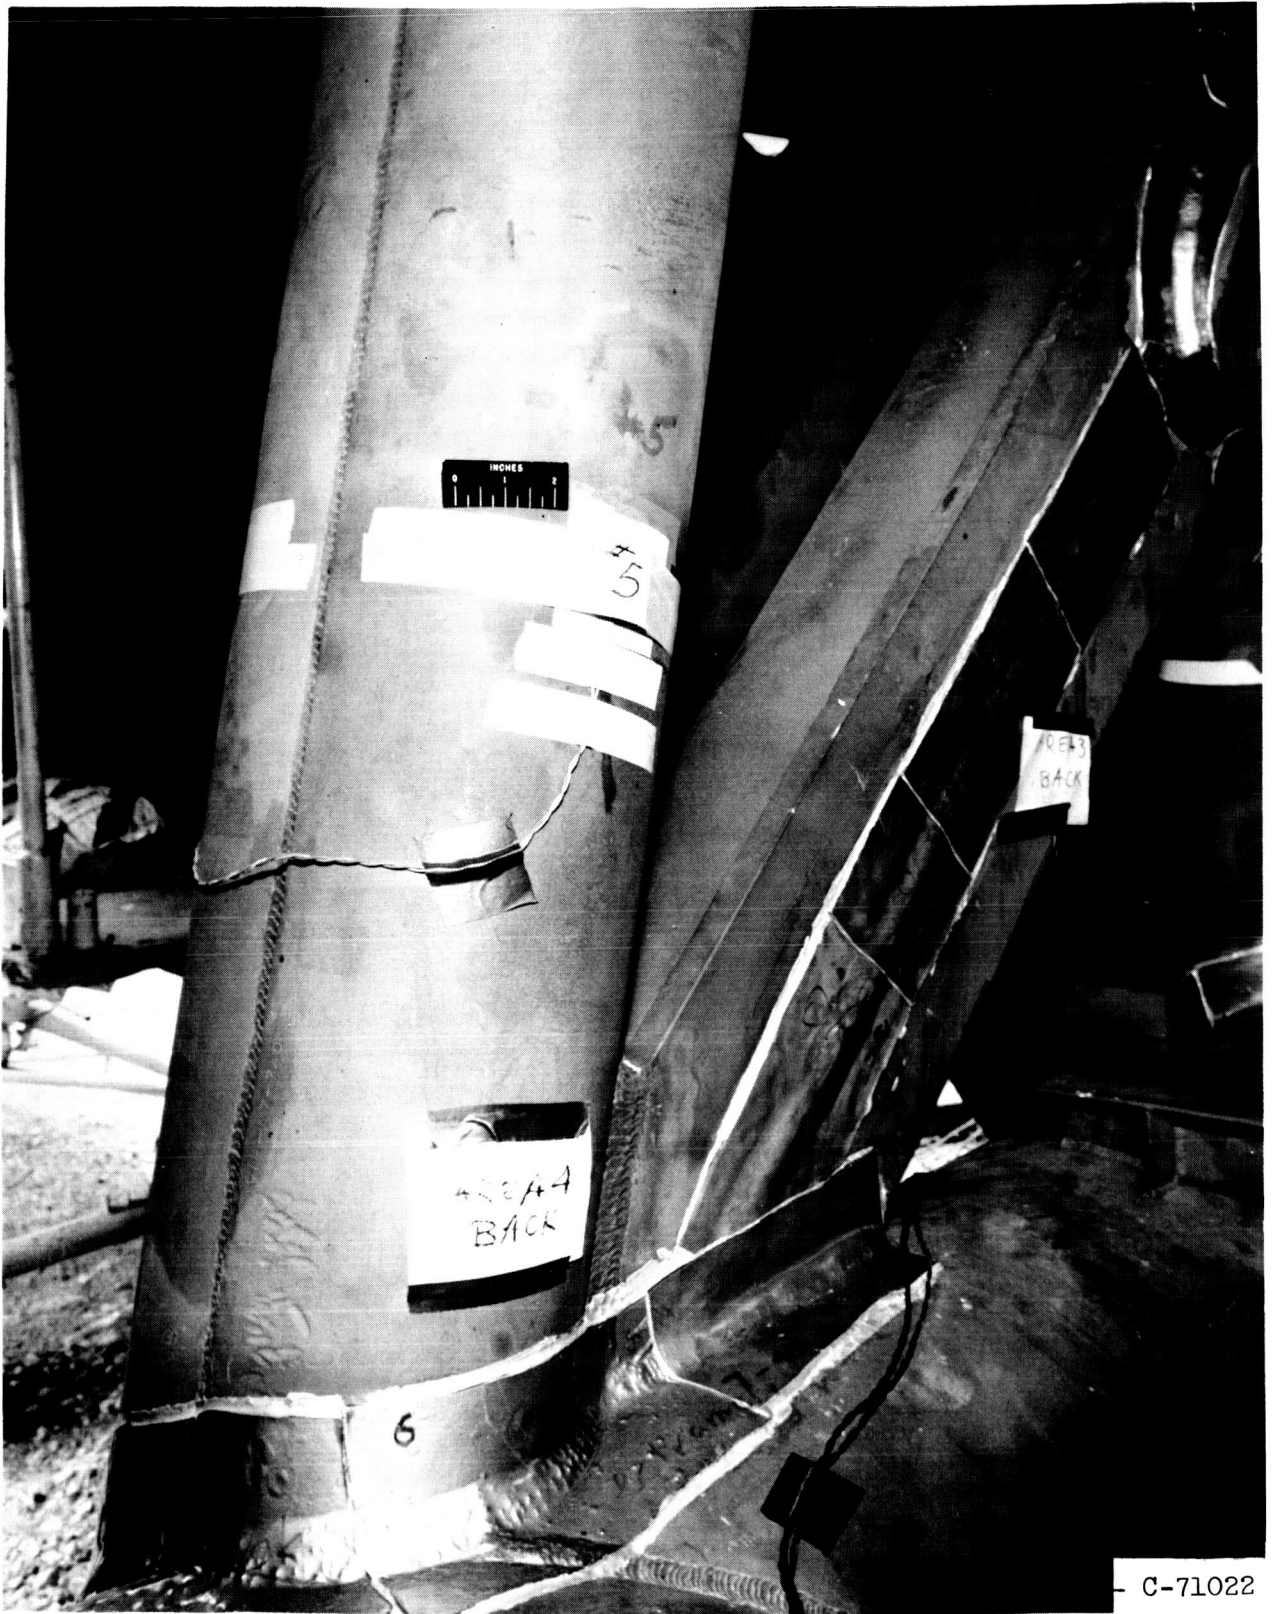
Figure 6. - Inside view of corner post horizontal frame joint in quadrant I showing strain gage 5.

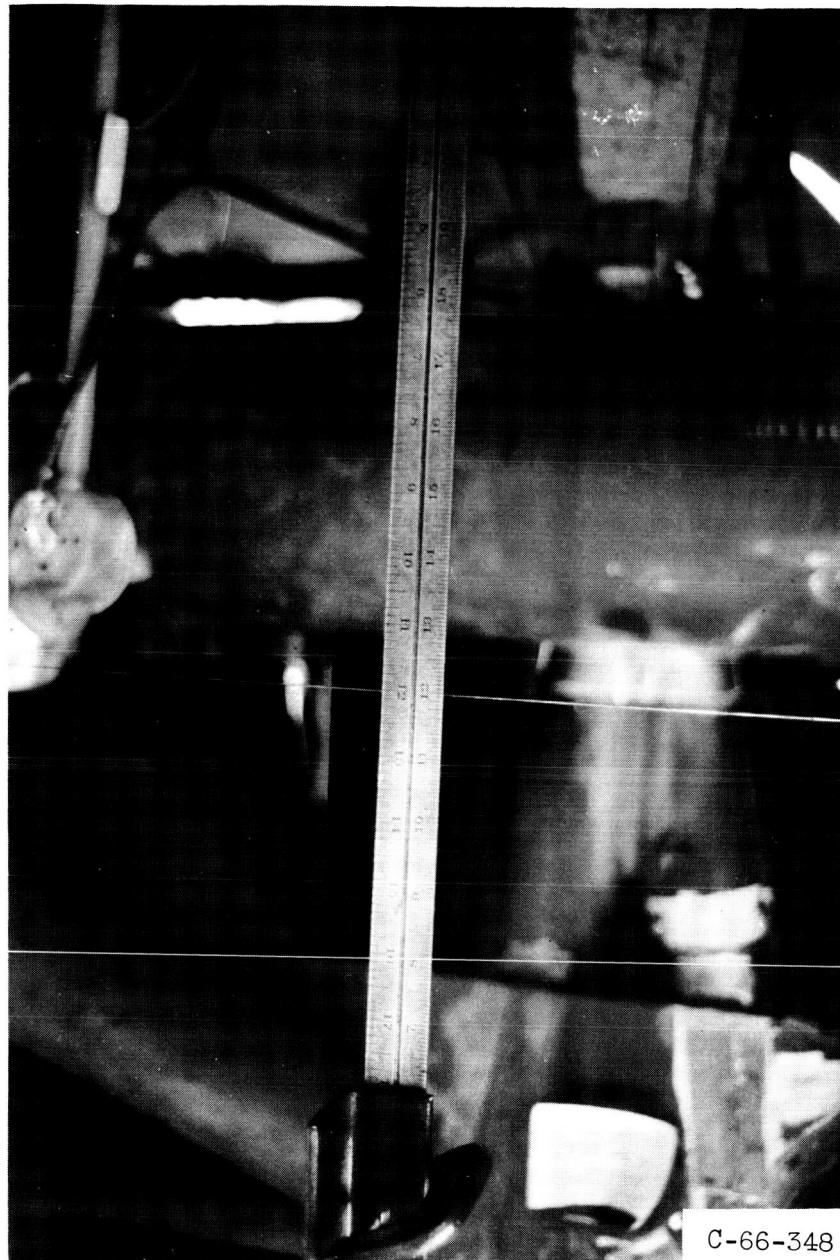
C-66-348

Figure 9. - Arrangement for measuring vertical deflection.

Scales were arranged to measure the change in the horizontal distances between centerlines of the 20-inch-diameter pipe and in the vertical distances between the horizontal centerline of the 20-inch-diameter pipe and the main support pin. These readings were made before and after the release of every load to check on any general yielding condition. (See fig. 9 for typical arrangement.)

The provisions that were made to indicate changes in two major dimensions on the launcher (see fig. 9) did not reveal any readable changes. It is therefore concluded that the loading did not cause any member failure or general yielding.

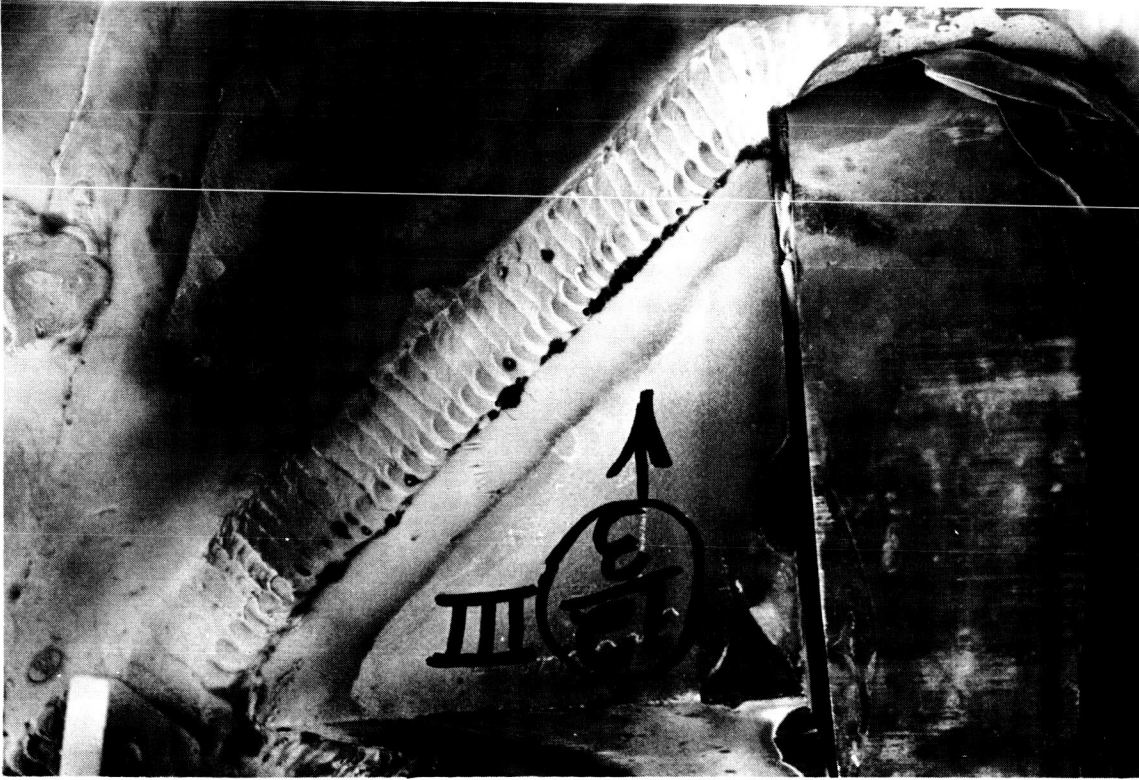
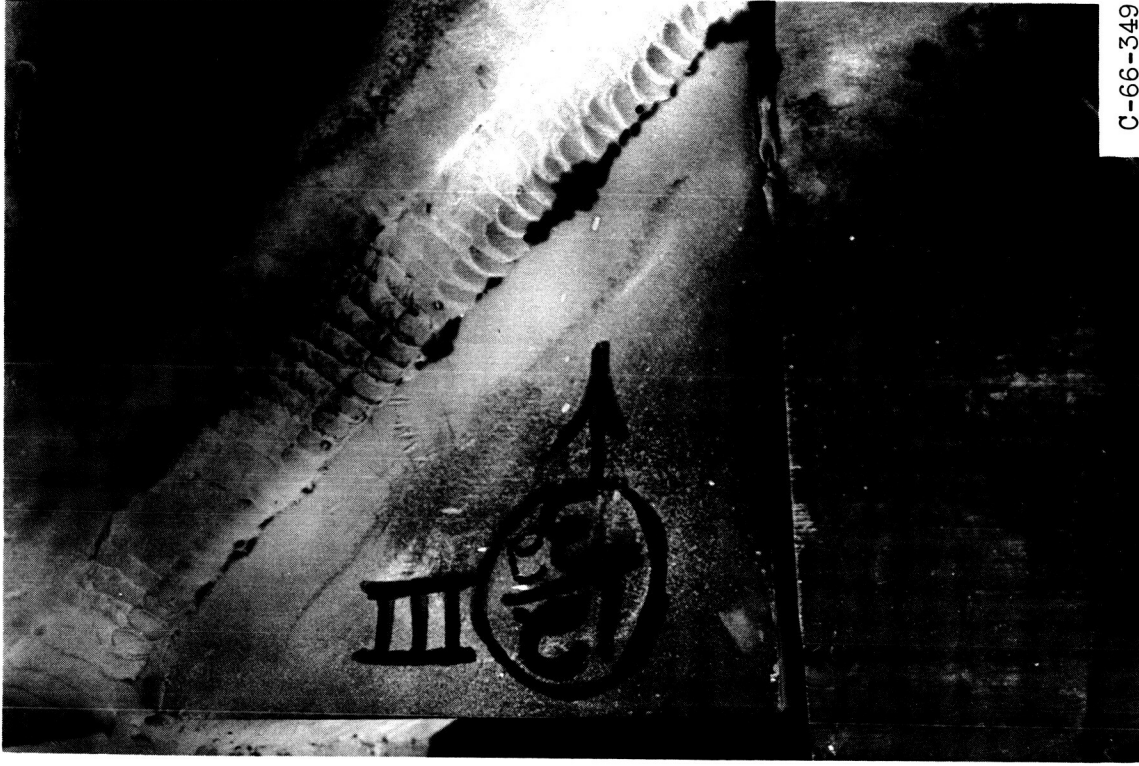
C-66-349

(a) Before loading in area 12.

(b) After loading in area 12.

Figure 11. - Dye-penetration indication before and after cyclic loading in quadrant III.

The major load-carrying welds in quadrants II and III were sandblasted in preparation for dye-penetrant inspection for the load cycle tests. The dye penetrant was not used in quadrants I and IV for the load cycle test, but cracks that were known to exist from prior inspection were identified by prick-punch marks before the loading began. After the application of a series of cyclic loads, the cracks were examined for growth by a dye-penetrant inspection conducted in accordance with MIL-I-6866. The photographs in figure 11 show typical areas before and after testing for the purpose of comparison.

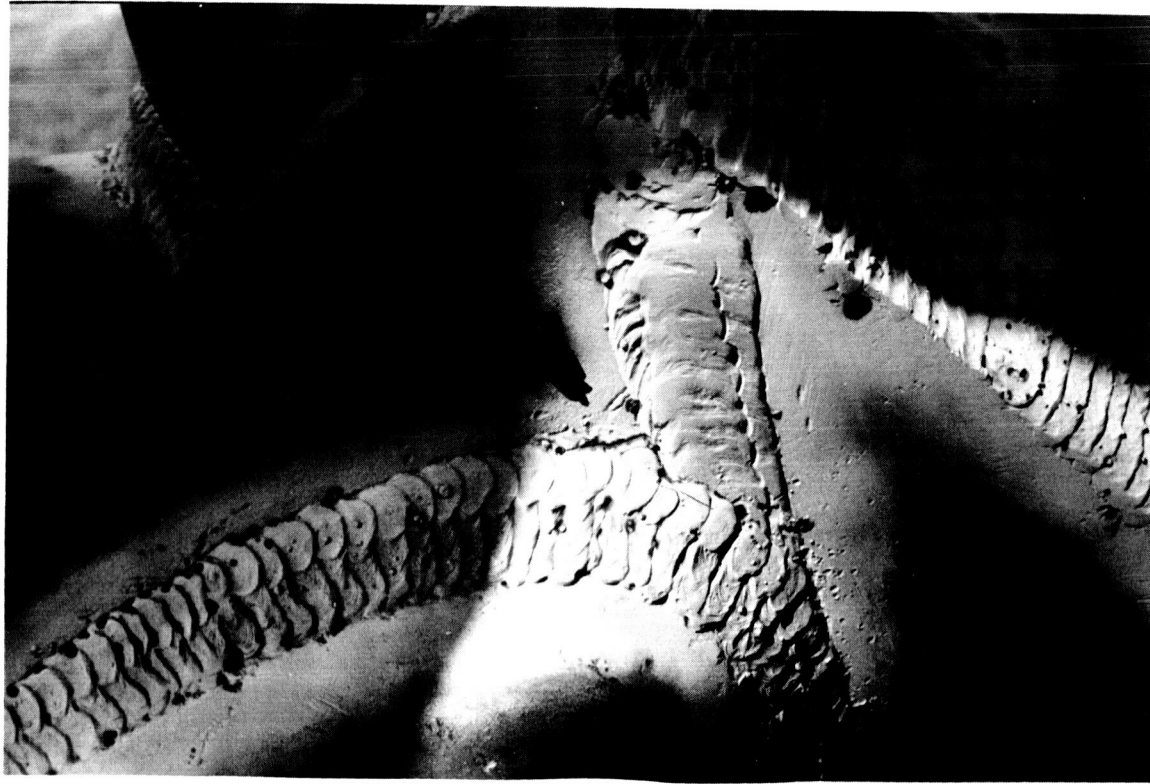
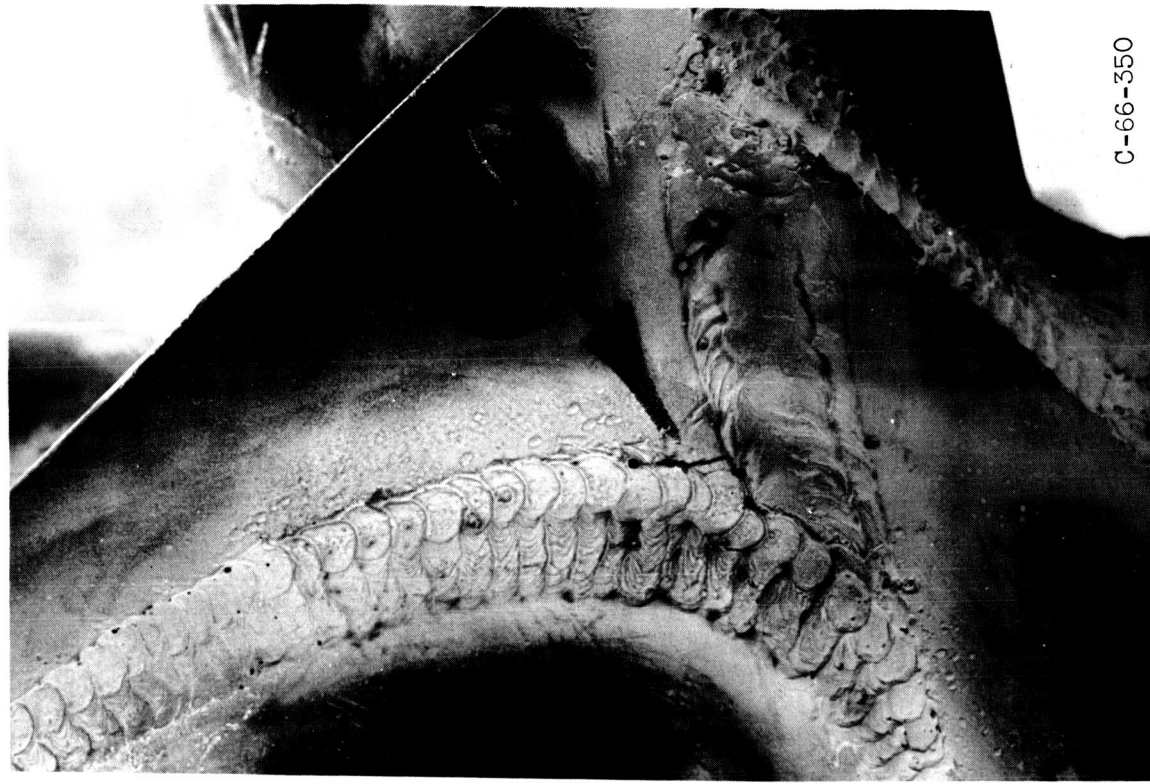
C-66-350

(c) Before loading in area 7.

(d) After loading in area 7.

Figure 11. - Continued.
